APOLLO 13 MISSION REPORT

SEPTEMBER 1970

MSC-02680

Mission Evaluation Team

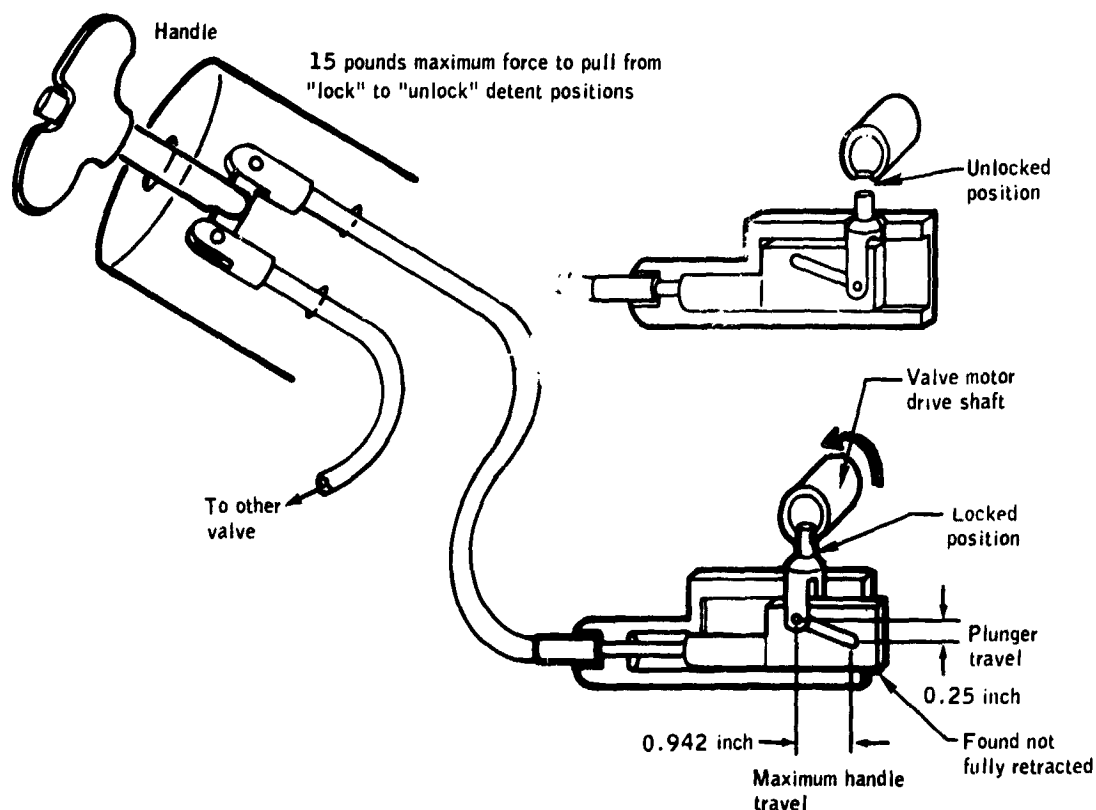
Figure 14-1.- Post-landing vent valve lock.

The valve-lock mechanism rigging tolerances were found to be within specifications. When reassembled in the spacecraft, the malfunction was duplicated with only partial travel of the handle.

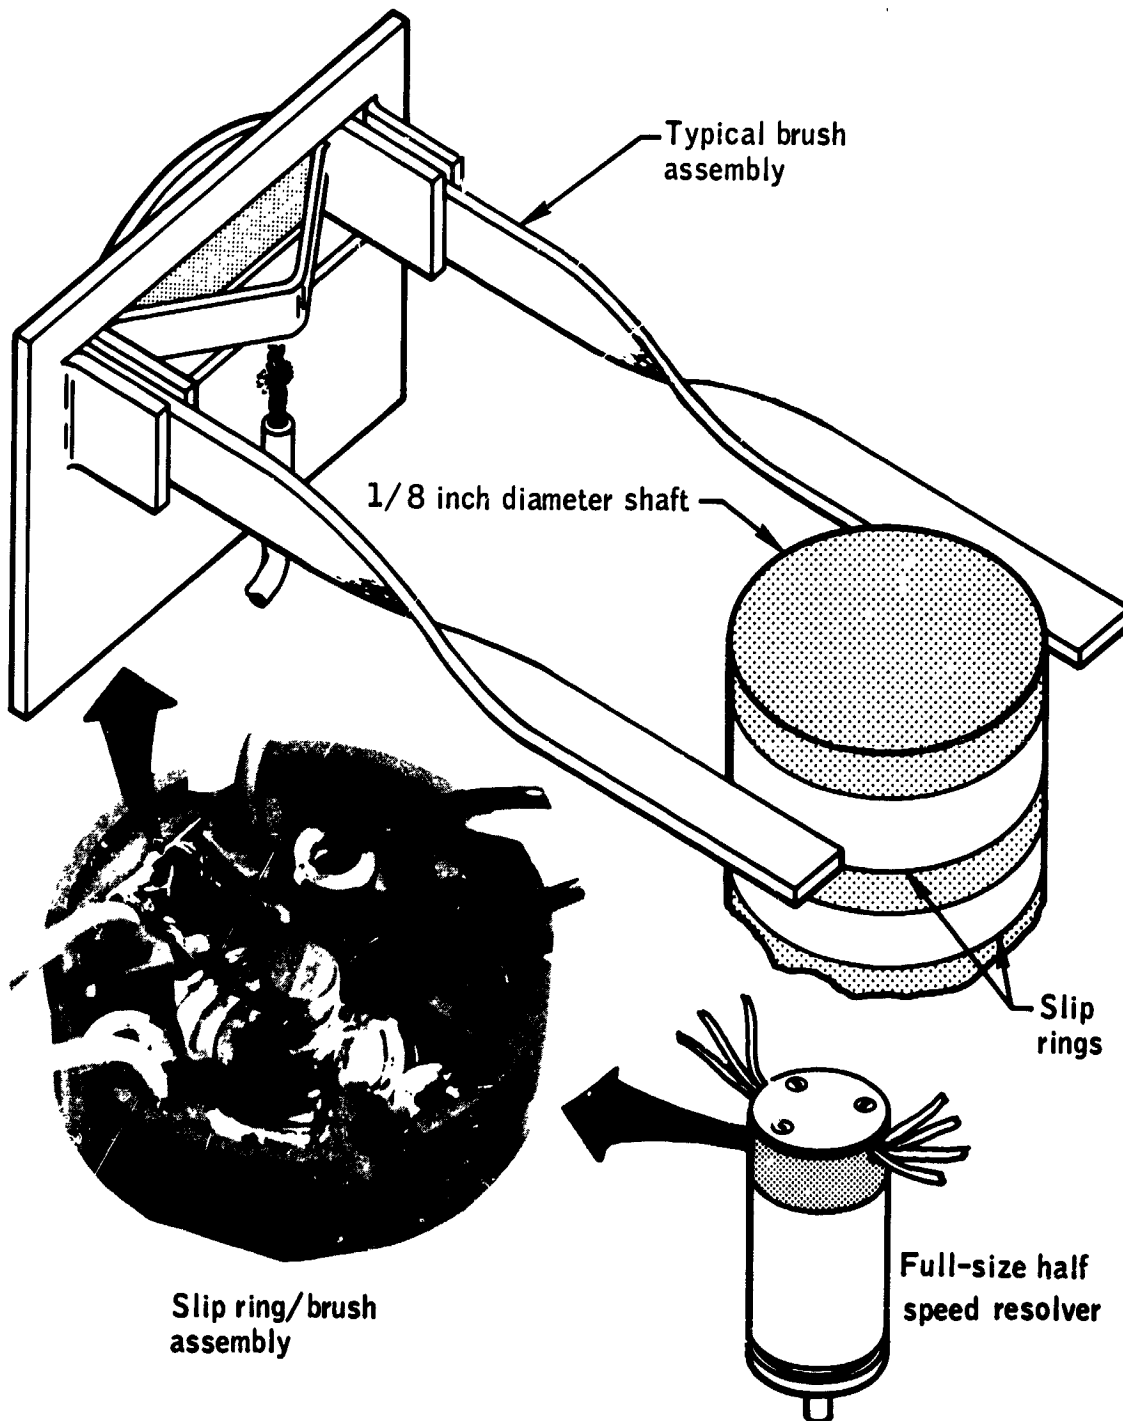
Figure 14-3.- Details of half speed resolver.

Some evidence of susceptibility to vacuum was exhibited in this class of resolvers during qualification testing when variations of approximately 5 ohms were observed in the slip ring resistance during thermal

vacuum testing. The tests were run with the units rotating at 1 rpm, however, and the momentary resistance changes disappeared with the wiping action.

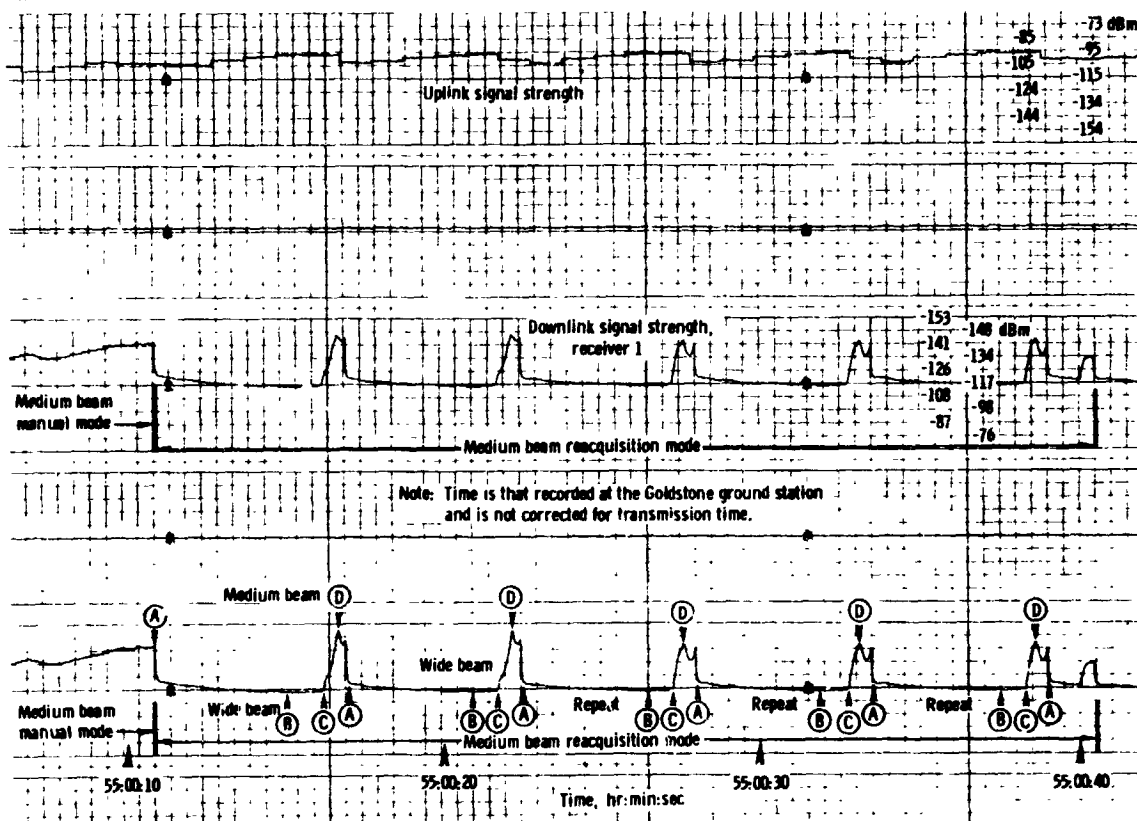
Figure 14-6.- Recorded signal strengths during high-gain antenna operation.

results of this test shifted the scan-limit functions but did not produce the necessary change in the scan-limit slope. Consequently, a failure in the electronic box is ruled out.

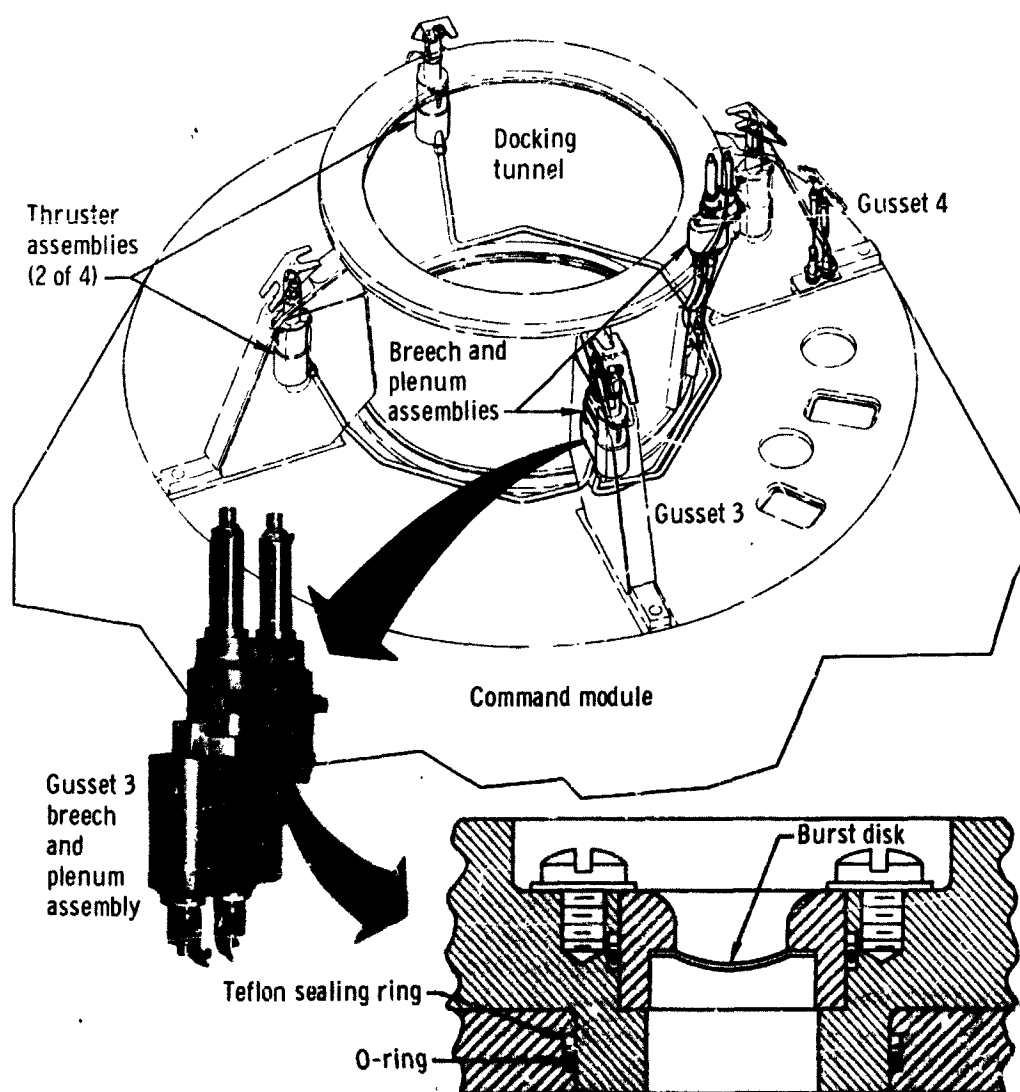
Figure 14-7.- Apex cover jettison system.

- a. Out of tolerance parts - Measurement of the failed parts indicate acceptable dimensions of the metal parts.
- b. Damaged O-rings - The 21 000-psi static proof-pressure test was successful.
- c. Gap in backup ring - The installation procedure specifies the backup ring may be trimmed on assembly to meet installation requirements,

but does not specify any dimensional control over the scarf joint. Since the gap portion was burned away, a gap in the backup ring could have caused the problem.

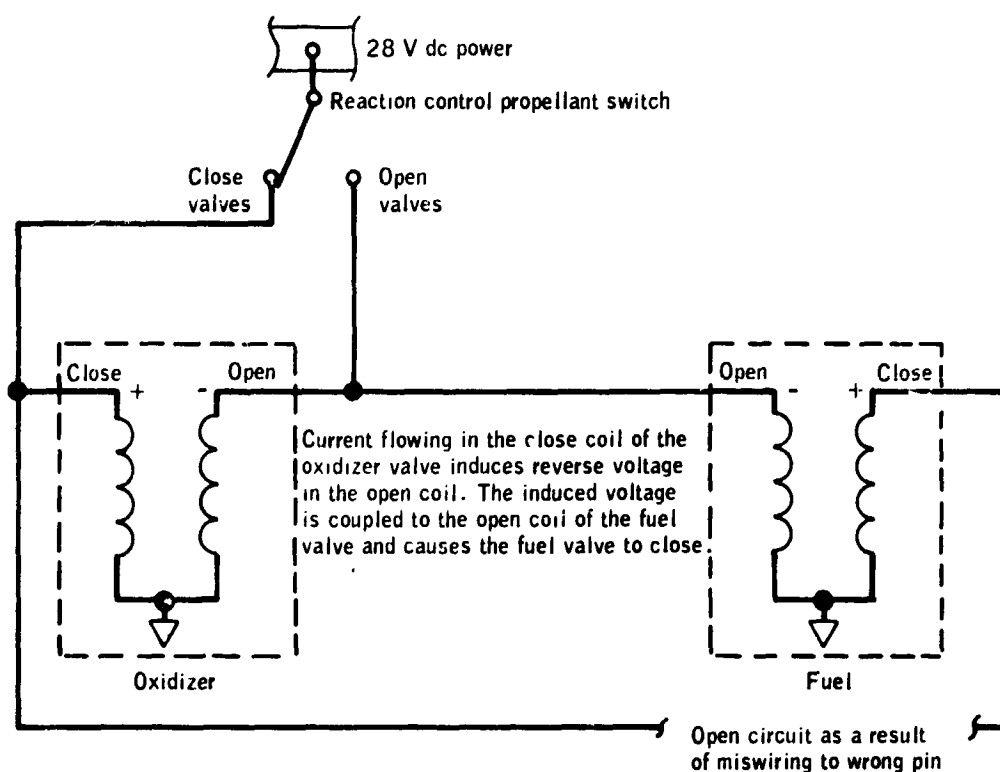
Figure 14-11.- Isolation valve circuit.

System decontamination at Hawaii was normal, except that the system 1 fuel isolation valve was found to be in the open position. All other propellant isolation valves were in the normal (closed) position. Power from ground servicing equipment was used to close the valve, which operated normally. Postflight investigation of this condition revealed that the electrical lead from the system 1 fuel-valve closing coil was miswired, making it impossible to apply power to this coil. This anomaly is discussed in section 14.1.7.

action. This voltage is applied to the fuel valve opening coil where it induces a magnetic field flux that closes the fuel valve. With 28 volts or more on the spacecraft bus, this phenomenon was consistently repeatable. With 24 to 28 volts on the bus, the valve would occasionally close, and with less than 24 volts, the valve would not close. Since preflight testing is accomplished at 28 volts, the functional tests did not disclose the miswiring. During the mission, the voltage was such that the valve did not close when commanded and therefore was found open after the flight.

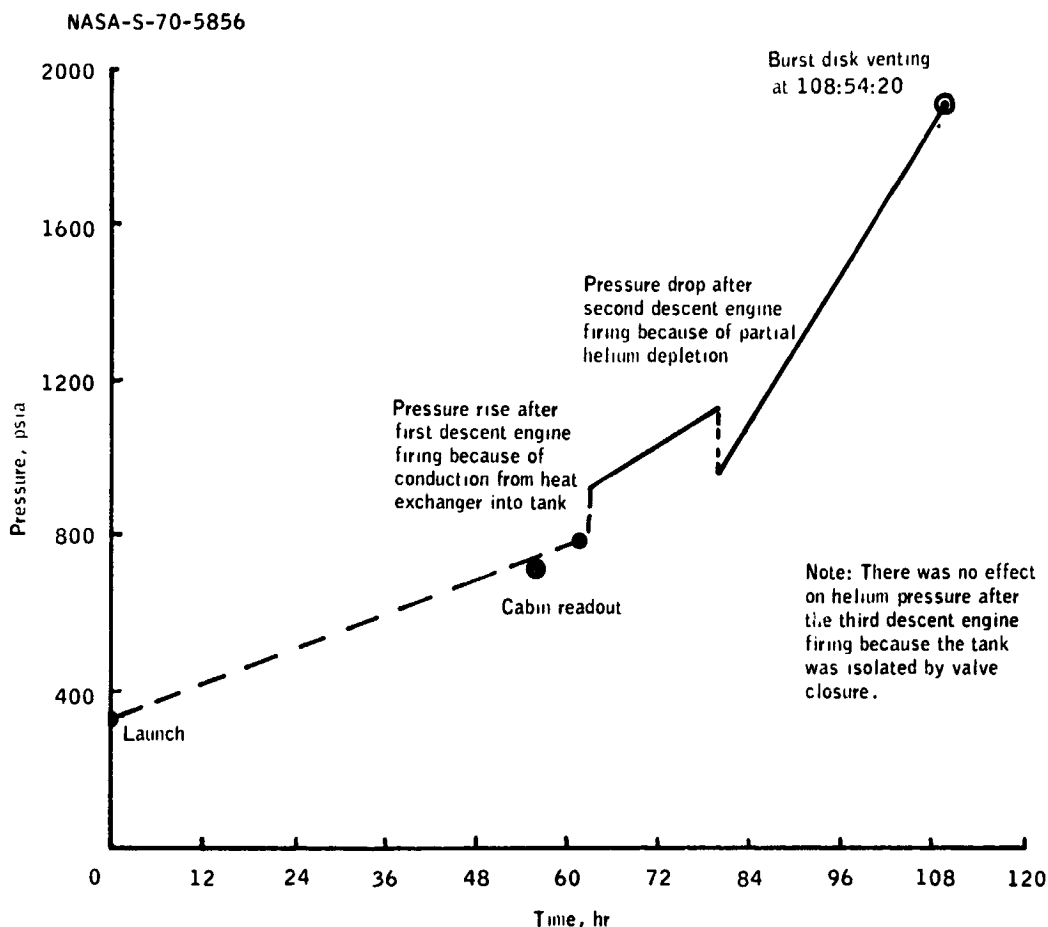
Figure 14-14.- Inflight profile of supercritical helium tank pressure.

The most likely cause of the anomaly is a tank-insulation degradation which would result in increased heat conduction to the helium. The insulating characteristics of the annular vacuum in tank was most likely degraded by the introduction of a contaminant (probably hydrogen) in extremely small concentrations (approximately 10^{-6} pounds). These contaminants when vaporized can exponentially increase the thermal conductivity in proportion to their vapor pressure, as indicated by special tests. While loading helium into the tank, the contaminants would freeze upon the inner shell. In the frozen state, the pressure of the contaminant is too low to significantly affect the thermal conductivity. However, the flow check which preceded the cold-soak operation would vaporize the contaminants in the vicinity of the heat exchanger lines which pass through the annulus. The subsequent increase in thermal conductivity could cause the abnormally high pressure-rise rate observed during the cold soak. These vapors would slowly condense on the cold (10° R) inner wall, resulting in the pressure rise rate dropping to the nominal level, as was observed. The rise rate would remain normal until the helium temperature increased above the vaporization temperature of the contaminant.

A screening test was devised for all future flight tanks to supplement normal helium tank testing. The purpose of this test is to determine the pressure rise rate for a wide range of helium temperatures from approximately 9° to 123° R. For a perfect tank, the steady-state rise rate should remain at approximately 8 psi/hour over the entire range of temperatures. The Apollo 14, 15, and 16 tanks have been subjected to the screening test, and each exhibit the same phenomena observed during Apollo 13, but to a lesser degree. For new tanks, the manufacturer will periodically analyze the gases removed from the vacuum jacket during pump down for possible contaminants. The pressure in the jacket will be measured 2 or 3 weeks after pumpdown to verify vacuum integrity.

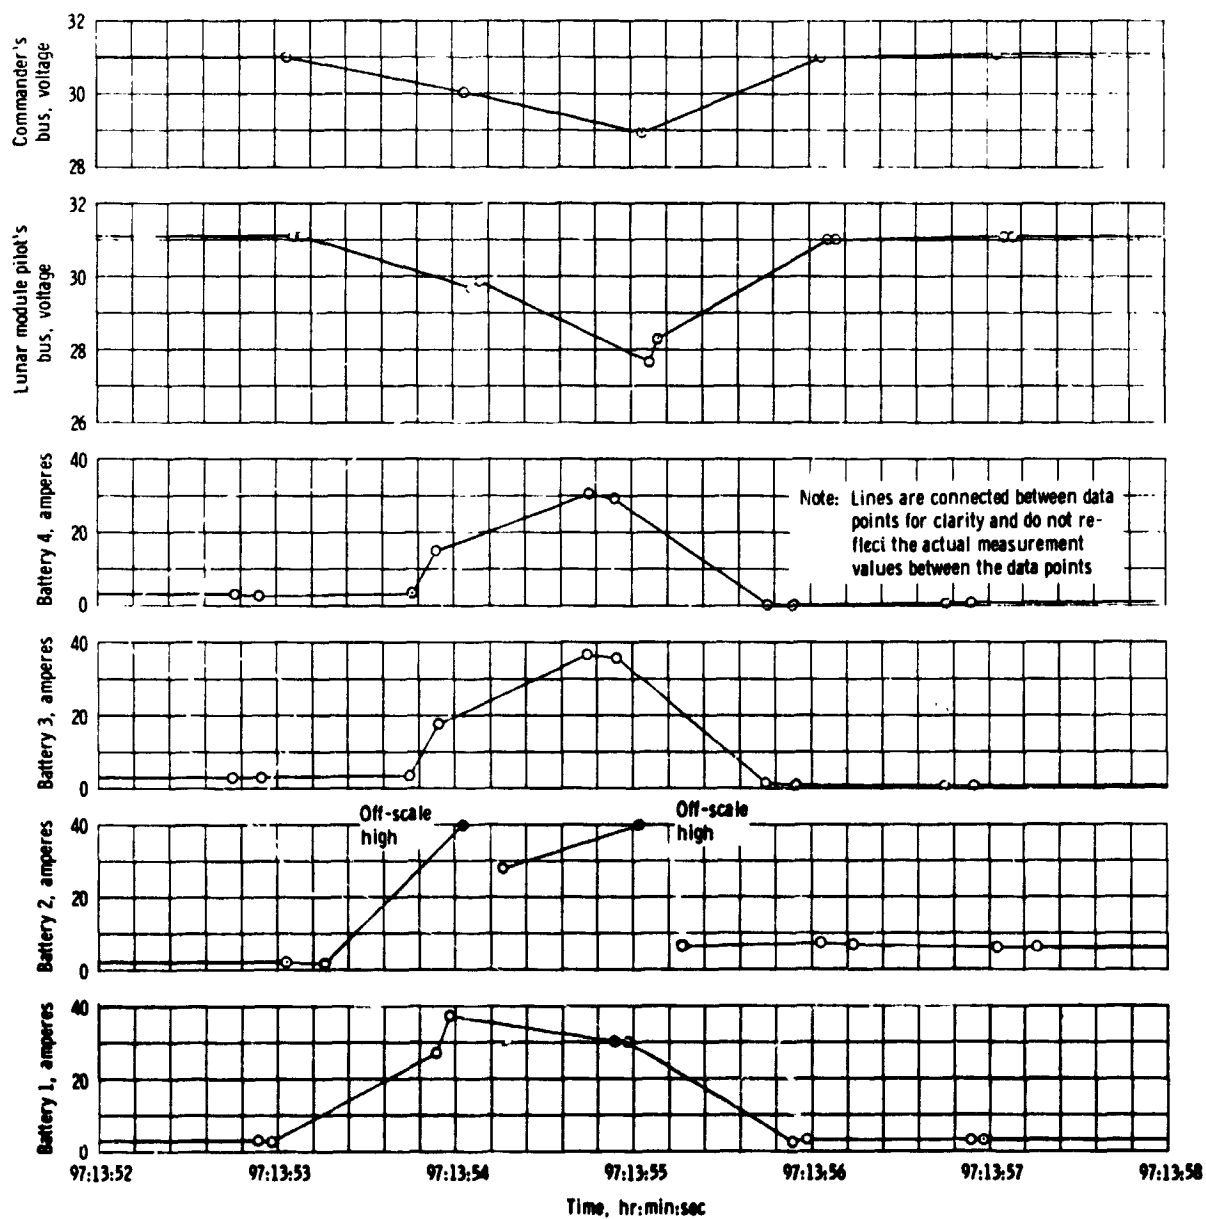
Figure 14-16.- Battery electrical transients.

The thumping noise occurred at about the same time as the current spikes. The current spikes show that a momentary short circuit existed in the Lunar-Module-Pilot side of the dc electrical system, which includes descent batteries 1 and 2 (fig. 14-16). The current surge was not of sufficient duration either to open the balance-load cross-tie circuit breakers, to display a reverse current indication, or to trip a battery-off relay as a result of an overcurrent condition.

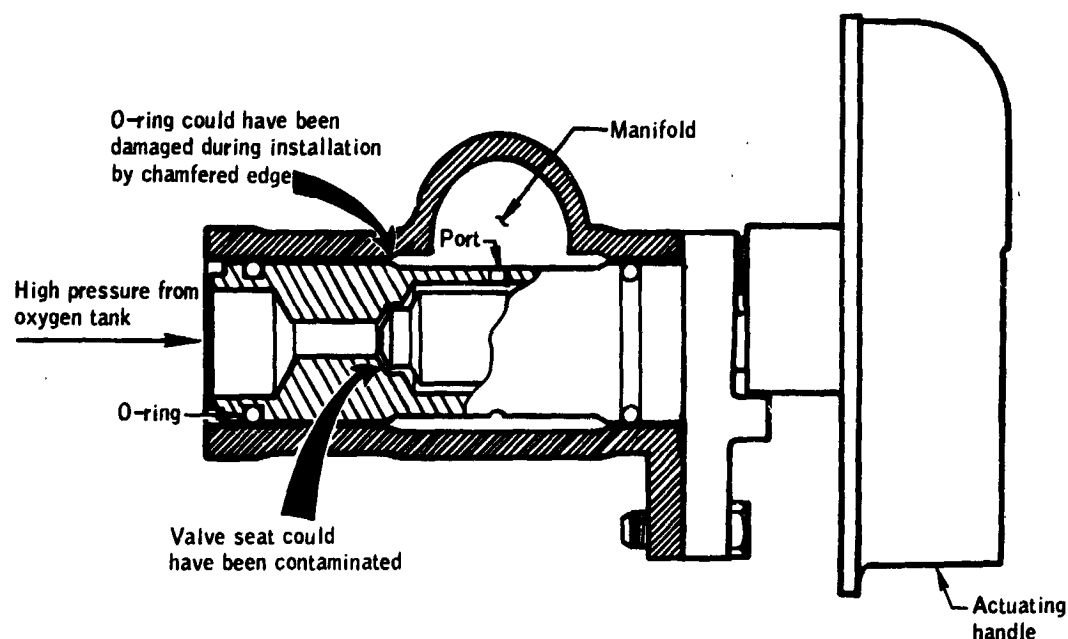
Figure 14-20.- Ascent stage tank shutoff valve.

The internal portion of three valves of this type had been replaced previously on the spacecraft because of excessive leakage through the ascent oxygen tank 1 shutoff valve. In one valve, a rolled O-ring

(fig. 14-20) caused the leakage. When the valve is installed, the forward O-ring can be rolled and damaged when it passes the manifold port. In the other two valves, the cause was not identified and was assumed to be contamination.

compression allowed in the valve design would aggravate the tendency for the O-ring to roll during valve assembly.
